Influence of Mechanical Layering and Natural Fractures on Undercutting and Rapid Headward Erosion (Recession) at Canyon Lake Spillway, Texas, U.S.A

Ledbetter Ferrill, N. S., & Ferrill, D. A. (2021). Influence of mechanical layering and natural fractures on undercutting and rapid headward erosion (recession) at Canyon Lake spillway, Texas, U.S.A. *Engineering Geology*, 280, Article 105897. <https://doi.org/10.1016/j.enggeo.2020.105897>

This study investigates the role of mechanical layering and fractures on flood-related erosional undercutting and resulting rapid spillway recession. In the summer of 2002, 86 cm of rain fell in an 8-day period across the Guadalupe River drainage basin in central Texas, causing Canyon Lake reservoir to completely fill and overtop the emergency spillway for the first time. The resulting flood incised a gorge into the mechanically layered Glen Rose Formation and caused headward erosion (recession) at the downstream edge of the emergency spillway. Comparison of pre- and post-flood imagery and assessment of flood records indicates that maximum recession localized at the northern end of the emergency spillway where 28 m recession occurred. This recession

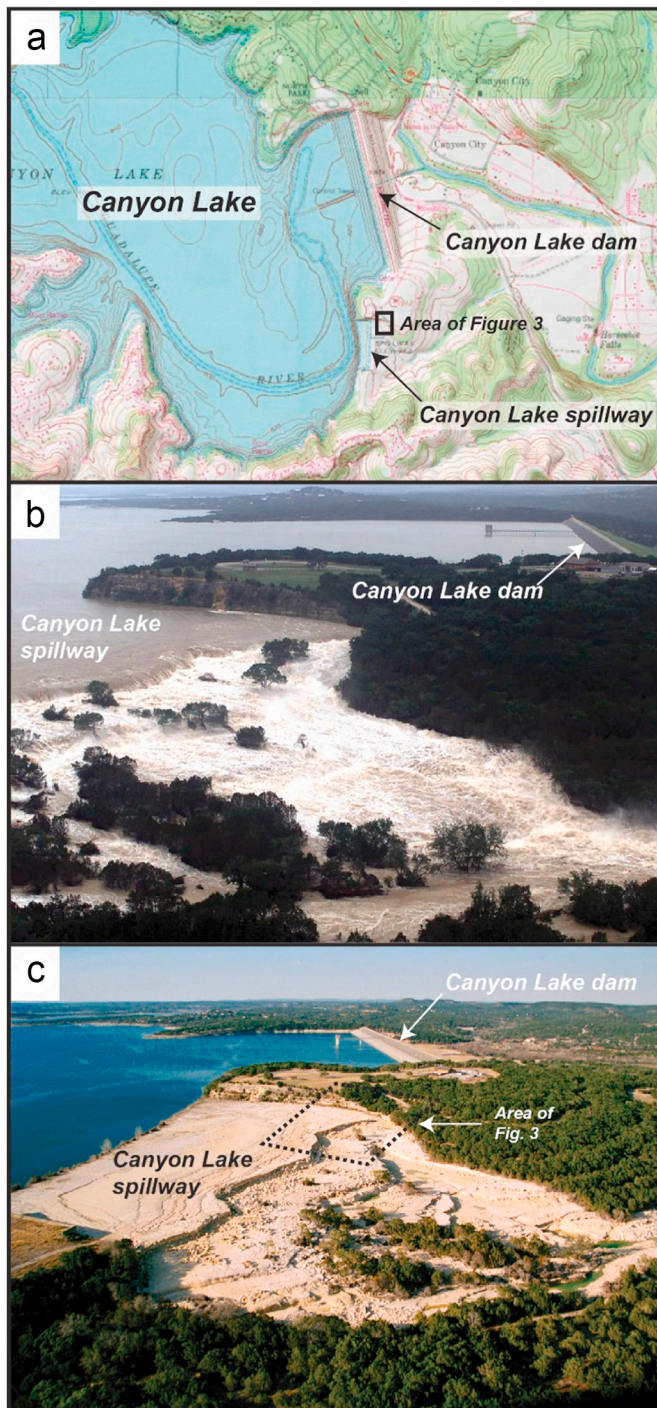
Fig. 2. (a) USGS topographic map of Canyon Dam on the Guadalupe River and spillway. (b) Photograph of Canyon Lake gorge during 2002 flood (photo credit, Comal County, Texas). (c) Photograph of Canyon Lake spillway and upper gorge on February 4, 2003.

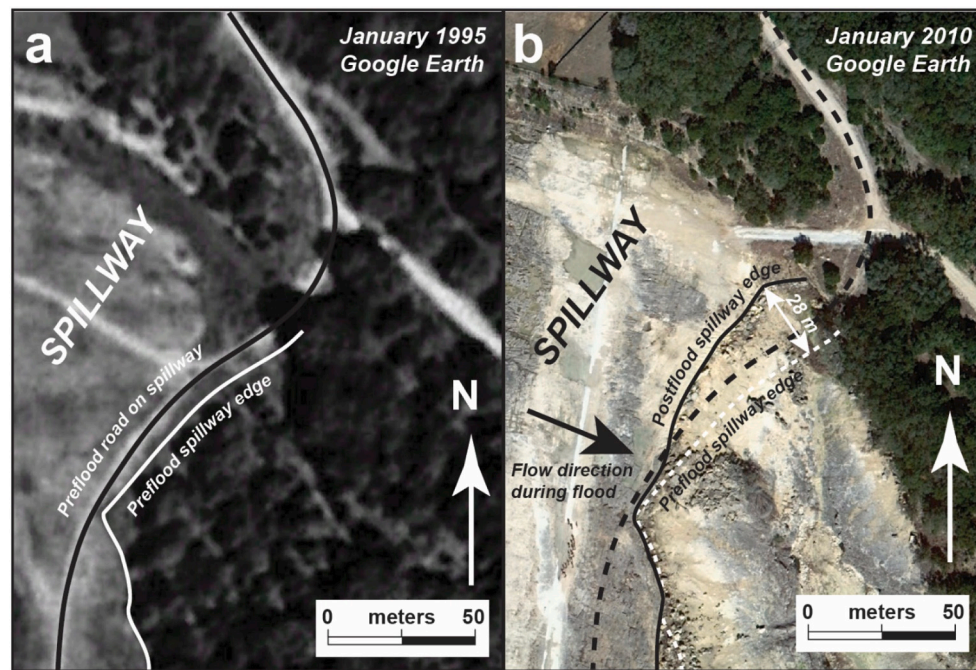
Fig. 3. Aerial imagery from Google Earth showing the spillway (a) before the flood (January 1995), and (b) after the flood (January 2010). Note that a road is visible on the north end of the spillway prior to the flood. Headward erosion (recession) along the downstream edge of the spillway produced 5 m to 28 m of recession along the northernmost 75 m of the spillway, removing a portion of the road.

Comparison of pre-flood and post flood imagery in Google Earth reveals that the downstream edge of the spillway, although eroded by the flood, did not experience major recession except for the northern-most approximately 75 m of the spillway. In pre-flood imagery of this area (Fig. 3a), an unpaved access road is visible between trees and continuing onto the emergency spillway surface. After the flood, the portion of the road on top of the spillway has been removed by recession of the spillway, and the access road between trees is abruptly truncated by the eroded cliff produced by the headwardly eroded gorge (Fig. 3b). Comparing the downstream edge of the spillway surface before (Fig. 3a) and after (Fig. 3b) the flood of 2002 shows that 5 m to 28 m of recession occurred during the flood of 2002 along the northern 75 m of the spillway. Maximum recession of 28 m occurred at the northern edge of the spillway.

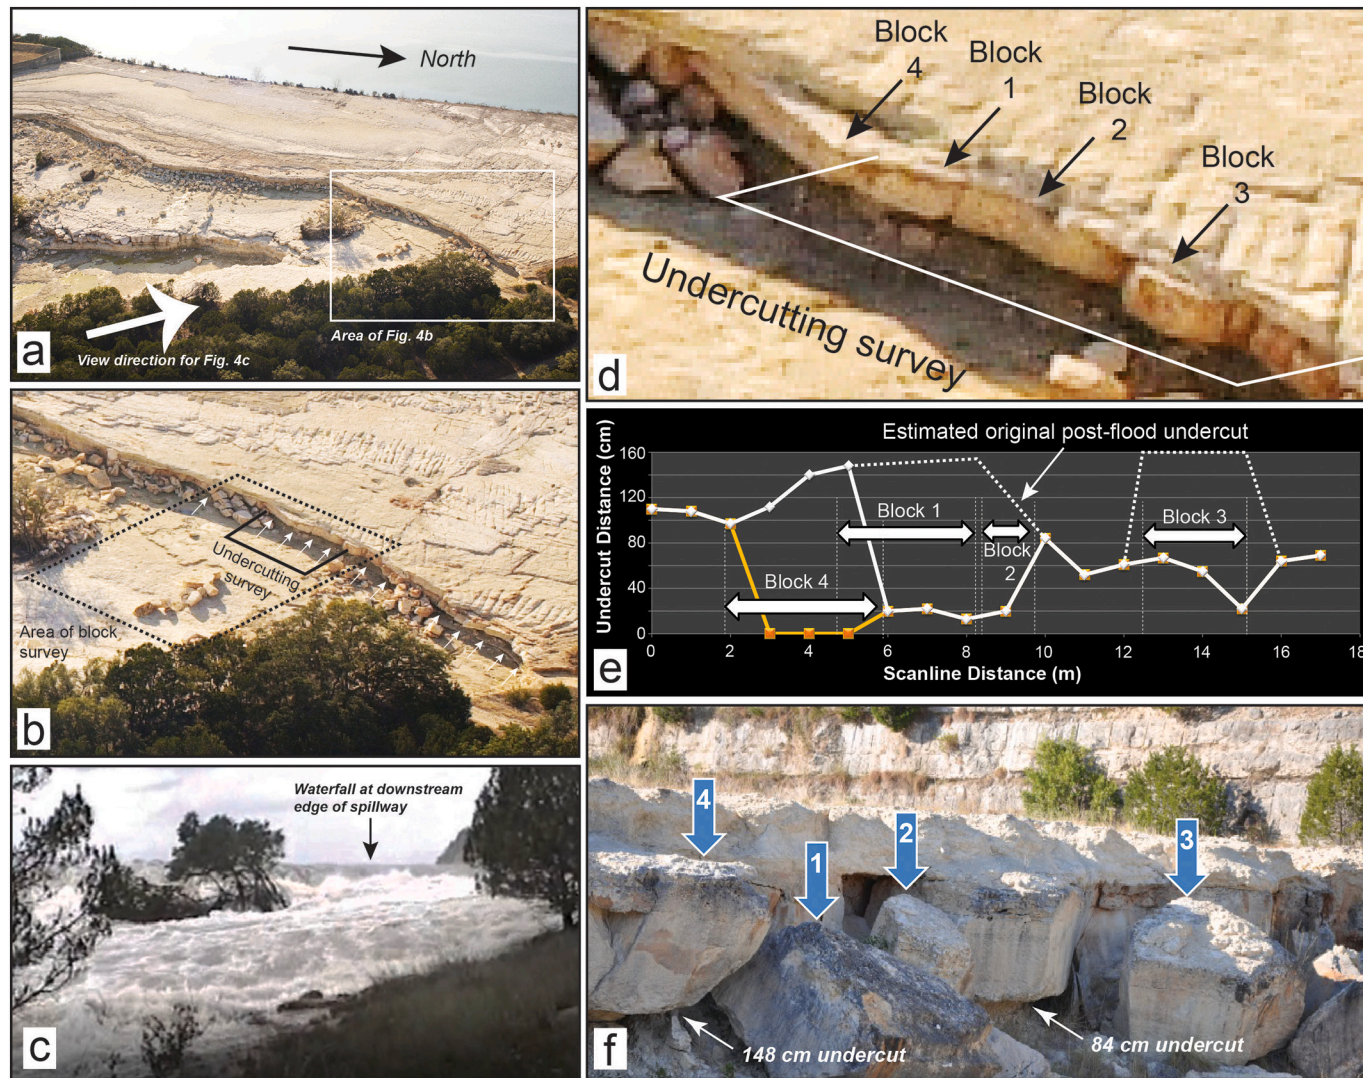
Fig. 4. (a) Photograph taken February 4, 2003, illustrating spillway and the eroded scarp at the downstream edge of the spillway. (b) Enlargement of part of the photograph in (a) where undercutting is visible along the scarp, as well as eroded blocks accumulated at the base of the scarp, and an elongate train of boulders along the pavement below the eroded scarp. (c) Image captured from video taken by Dan Cardenas in July 2002 during flood conditions. The waterfall noted in the image corresponds to the section of the spillway edge that is shown in Fig. 4b – note intense turbulence at the base of the falls, where undercutting occurred. (d) Further enlargement of photograph (b) detailing post-flood undercutting. Note this photo illustrates blocks 1–4 had large undercuts pre-collapse. (e) Profile illustrating undercut distance measured along a scanline parallel to the small scarp, with measurement spacing of 1 m. Undercutting was observed in marl at the base of the massive limestone in the cliff. Maximum undercutting of 1.5 m recorded in October 2015 (white line on graph) was site of collapse of Block 4 in 2016, with gold line illustrating the resulting undercutting profile. (f) Photo October 5, 2015 at time of original undercutting measurements, prior to the fall of Block 4. (For interpretation of the references to colour in this figure legend, the reader is referred to the web version of this article.)

Undercutting was observed in argillaceous packstone and wackestone (clay rich marl) between the stratigraphic heights of 51.0 m and 53.2 m (Fig. 4a). Undercut distance was measured along a 17 m scanline parallel to the scarp where the section from the spillway to near the base of the cliff was accessible (i.e., not covered by eroded blocks; Fig. 4b). This undercut was created predominantly during the 2002 flood (Fig. 4c), leaving unsupported limestone blocks throughout the study site (Fig. 4d). Undercut distance measurements were made horizontally, with measurement spacing of 1 m. Maximum undercutting of 1.48 m was initially recorded in October 2015, which is illustrated by the white line on the graph in Fig. 4e. Upon revisiting the following year – October 2016 – we found that this location was the site of toppling collapse of a block (labelled Block 4 in October 2015 photo in Fig. 4f). The gold line in Fig. 4e illustrates the updated undercutting profile after that rockfall/toppling event, and the dashed white line represents estimated original post-flood undercut (see photograph in Fig. 4d).

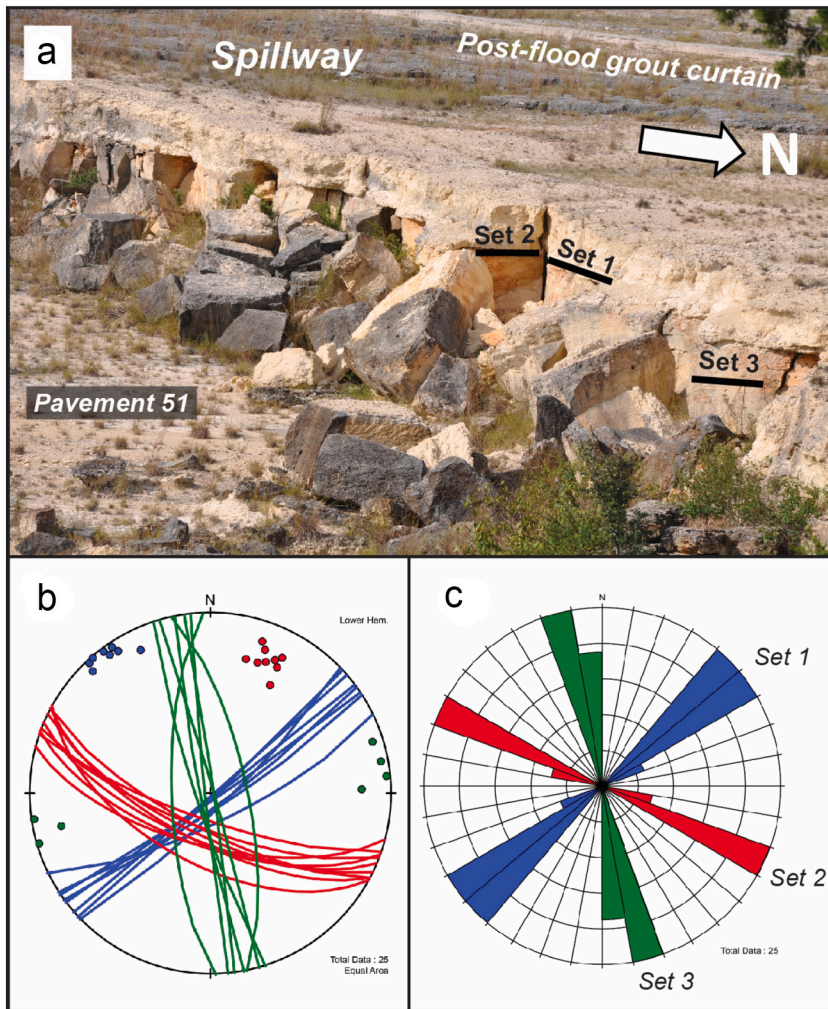
Fig. 6. (a) Field photograph (October 2016) showing fractures along downstream edge of spillway. (b) Equal area stereographic projection illustrating poles (dots) and great circles for measured fractures of each of the three systematic fracture sets. (c) Rose diagram illustrating the strike of fractures in each set. Set 1 (Blue) = $51.38^\circ \pm 3.9^\circ$; Set 2 (Red) = $113.75^\circ \pm 4.57^\circ$; Set 3 (Green) = $169.17^\circ \pm 5.49^\circ$. (For interpretation of the references to colour in this figure legend, the reader is referred to the web version of this article.)

Three systematic fracture sets were identified in the headwardly eroded emergency spillway cliff (Fig. 6a). Orientations were measured for each set, and average strike/dip and spacing were calculated as follows: (i) Set 1–051/86, mean spacing 77 ± 70 cm; (ii) Set 2–114/68, mean spacing = 152 ± 90 cm; and (iii) Set 3–169/82, mean spacing = 256 ± 70 cm (Fig. 6b, c). The 051/86 fracture set is the dominant regional fracture set, and parallels the strike of the Hidden Valley fault exposed in Canyon Lake gorge and the dominant normal fault strikes in the Balcones fault zone in the region more broadly (Ferrill et al., 2011; McGinnis et al., 2015; Fig. 1). It is also noteworthy that Set 1 fractures

parallel the pre-flood spillway edge in the north end of the spillway, and are normal to the flow direction and represent the primary release planes for block toppling and rockfall.

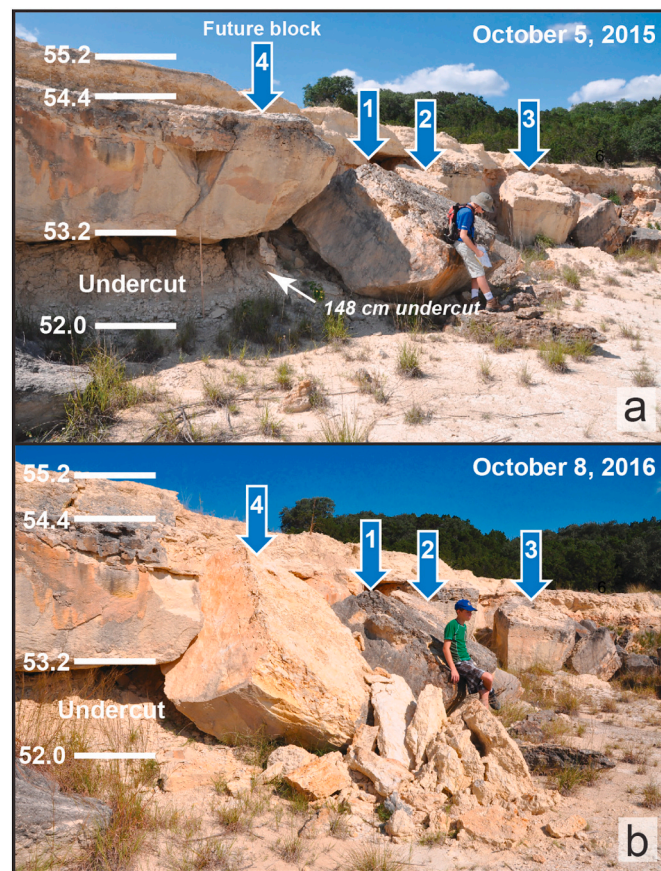
Between October 2015 and October 2016, a new rockfall occurred (Fig. 8a, b). The rockfall occurred (Fig. 8b) where maximum undercutting of 148 cm was measured and documented during field research the previous year (Fig. 8a). Based on analysis of Google Earth historical images, the block toppled between February and October 2016. This new block (Fig. 8b) is bounded by fractures on lateral sides, and bedding partings/weaknesses on top and bottom. Block bounding fractures are not newly formed, but instead exhibit mineralization that indicates they are pre-existing natural fractures that reactivated (Fig. 8a). Lateral block boundaries are represented by fractures including both opening mode fractures with calcite mineralization, and minor shear fractures ornamented with slickenlines. The top of the block is defined by the distinctive burrowed layer, and the overlying argillaceous limestone sheared off and is now represented by smaller blocks and rubble (Fig. 8b).

Fig. 8. Toppling failure continues, associated with erosional undercut. (a) Photograph taken October 5, 2015, with several toppled blocks identified. (b) Photograph from the same location taken October 8, 2016 shows a newly toppled block (4). Rubble at the bottom of block 4 represents relatively weak argillaceous limestone from stratigraphic height 54.4–55.2 that sheared off the top of the toppled block.

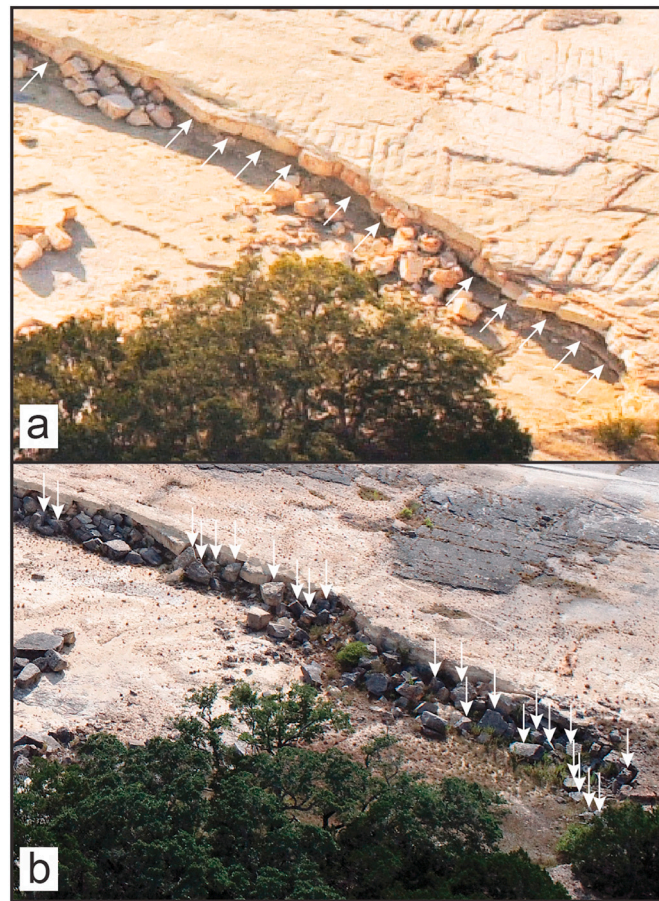
Post-flood erosion by rockfall continues and has locally produced an additional 1 to 2 m of post flood recession, primarily associated with collapse where pronounced undercutting at the base of the spillway cliff was preserved at the end of flood (Fig. 11a), and through time blocks have collapsed (Fig. 11b). Toppling failure and rockfall has continued well over a decade after the flood, including the toppling of Block 4 between February and October 2016, which was described and documented before and after the rockfall. Observations of this ongoing

Fig. 11. (a) Photograph from February 4, 2003 illustrating post-flood undercutting along the scarp, indicated by white arrows. (b) Photograph from July 24, 2020 showing the collapse of 23 new blocks, indicated by vertical white arrows. Collapse of these blocks has led to locally 1–2 m of post-flood recession of the emergency spillway edge.
