Influence of Mechanical Layering and Natural Fractures on Undercutting and Rapid Headward Erosion (Recession) at Canyon Lake Spillway, Texas, U.S.A

Ledbetter Ferrill, N. S., & Ferrill, D. A. (2021). Influence of mechanical layering and natural fractures on undercutting and rapid headward erosion (recession) at Canyon Lake spillway, Texas, U.S.A. *Engineering Geology*, 280, Article 105897. <https://doi.org/10.1016/j.enggeo.2020.105897>

This study investigates the role of mechanical layering and fractures on flood-related erosional undercutting and resulting rapid spillway recession. In the summer of 2002, 86 cm of rain fell in an 8-day period across the Guadalupe River drainage basin in central Texas, causing Canyon Lake reservoir to completely fill and overtop the emergency spillway for the first time. The resulting flood incised a gorge into the mechanically layered Glen Rose Formation and caused headward erosion (recession) at the downstream edge of the emergency spillway. Comparison of pre- and post-flood imagery and assessment of flood records indicates that maximum recession localized at the northern end of the emergency spillway where 28 m recession occurred. This recession

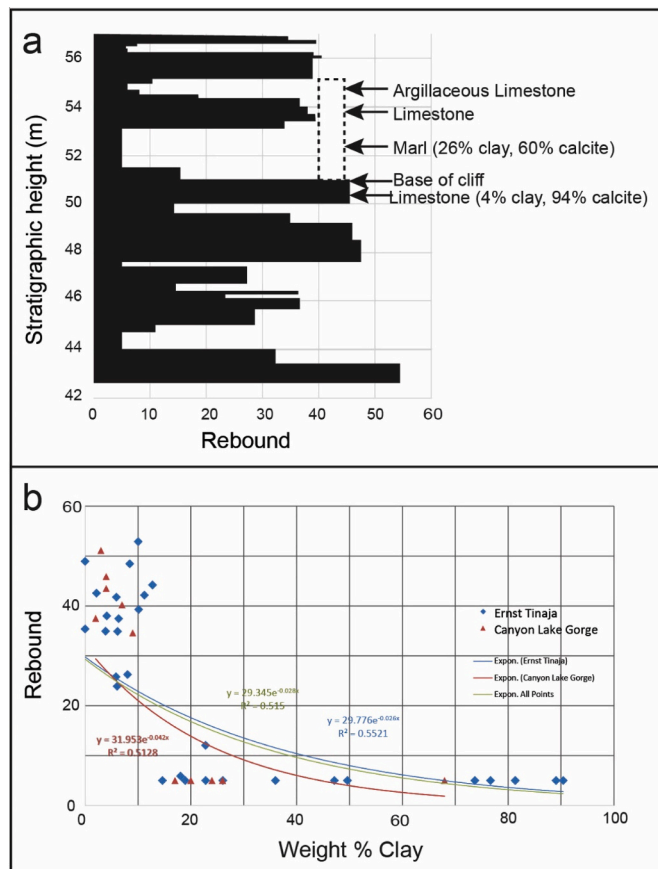
Fig. 5. (a) Schmidt rebound profile for the eroded upper spillway at Canyon Lake emergency spillway, including the eroded spillway cliff section. (b) Plot of rebound versus percent clay including data from the Glen Rose Formation at Canyon Lake gorge (Ferrill et al., 2011) and Boquillas Formation at Ernst Tinaja in Big Bend National Park, west Texas (McGinnis et al. 2017) shows an inverse correlation of increasing clay to decreasing competence. A major step change in behavior occurs at 15% clay. An exponential best-fit line is statistically significant, with R-value of 0.515. (For interpretation of the references to colour in this figure legend, the reader is referred to the web version of this article.)

Rebound measurements were made horizontally against vertical outcrop surfaces (10 measurements per interval) and averaged to determine mean rebound for each bed within the section exposed in the eroded cliff at the downstream edge of the spillway. In making the measurements, we were able to find relatively unweathered limestone surfaces to measure on, and in weathered marl intervals, we were able to scrape through the weathered rind using a rock hammer to expose fresh rock to measure from. A rebound profile was generated using mean rebound values and interval thicknesses measured in the field (Fig. 5a). Average rebound values range from 5.0 in the clay-rich marl (packstone and wackestone) at the base of the cliff, to 39.4 in the overlying thick limestone bed that represents the dominant competent layer in the eroded cliff. To assess whether rebound values have changed significantly over time, we compare our new rebound measurements to rebound data collected from this section in 2008, 6 years after the flood of 2002, and published in Ferrill et al. (2011). Measurements for the

Undercutting and toppling associated with erosion at Canyon Lake gorge has been strongly influenced by mechanical layering and the pre-existing natural fracture network. Analysis of the mechanical layering using the Schmidt (type N) rebound hammer revealed dramatic contrast within the eroded emergency spillway section, with undercutting focused along the weakest layer in the section (Fig. 5a). A comparison of rebound versus weight percent clay from XRD whole-rock mineralogy data sets collected from the Cretaceous Glen Rose Limestone at Canyon Lake gorge (Ferrill et al., 2011) along with data from the Cretaceous Boquillas Formation (limestone, chalk, carbonate mudrock) in Big Bend National Park (McGinnis et al., 2017) shows a strong relationship between increasing clay content and lower rebound (i.e., weaker rock) (Fig. 5b). Specific to this study, clay content is 26 wt% sampled from stratigraphic height of 52.8 (rebound = 5), whereas the underlying limestone has 4 wt% clay sampled from stratigraphic height = 50.8 (rebound = 45.9). It is apparent that clay content is a primary control on rock strength and erodibility in carbonate strata. Rock mechanical properties alone do not, however, control the headward erosion process. Whereas clay rich strata are not prone to brittle fracturing, competent limestone has low ductility and does commonly contain natural fractures (Ferrill et al., 2014; McGinnis et al., 2015, 2017). These fractures are a key contributor to the headward erosion observed from Canyon Lake spillway.

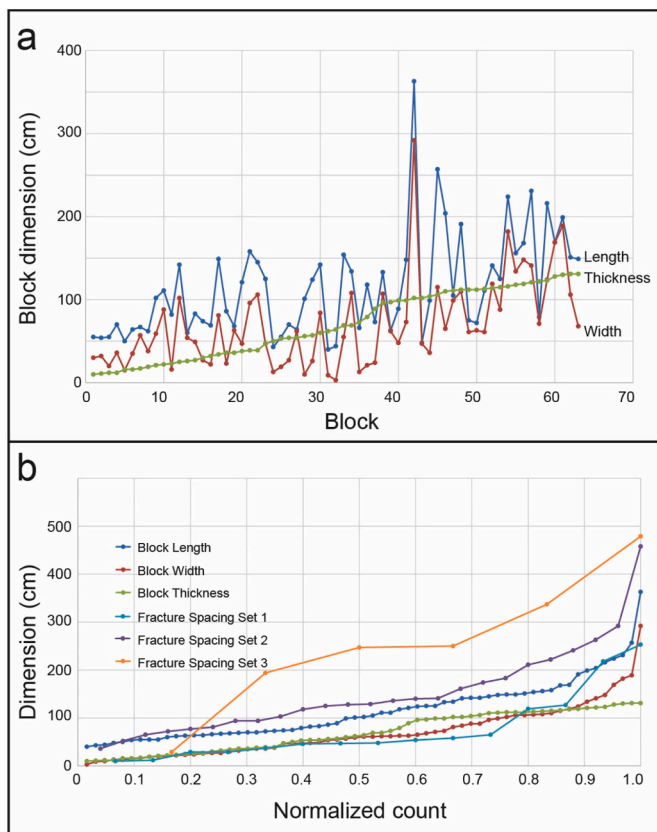
Fig. 7. (a) Graph of block dimension values vs block number ordered according to thickness dimension. (b) Graph of block dimension values vs normalized count showing that natural fracture spacings generally bracket the block dimensions. Whereas block thickness is controlled by mechanical layer thicknesses, length and width of blocks is determined by pre-existing fracture spacings.

A graph of block dimensions – including thickness, length, and width for the 63 blocks ordered by thickness – illustrates the limited thickness range from 10 to 131 cm (Fig. 7a). In contrast, length and width show much greater variability. Maximum block thickness is controlled primarily by the relatively uniform mechanical layer thickness for the dominant competent limestone bed including the burrowed top (stratigraphic height 53.2 to 54.5 m). In contrast, the highly variable lateral dimensions of blocks are a function of the variable natural fracture spacing for each of the fracture sets that can in combination lead to a wide range of lateral dimensions. Plotting the three block dimensions as well as spacing for the three fracture sets on a graph of dimensions versus normalized count shows that natural fracture spacings generally bracket the block dimensions, supporting the interpretation that lateral block dimensions are controlled by pre-existing fractures (Fig. 7b).

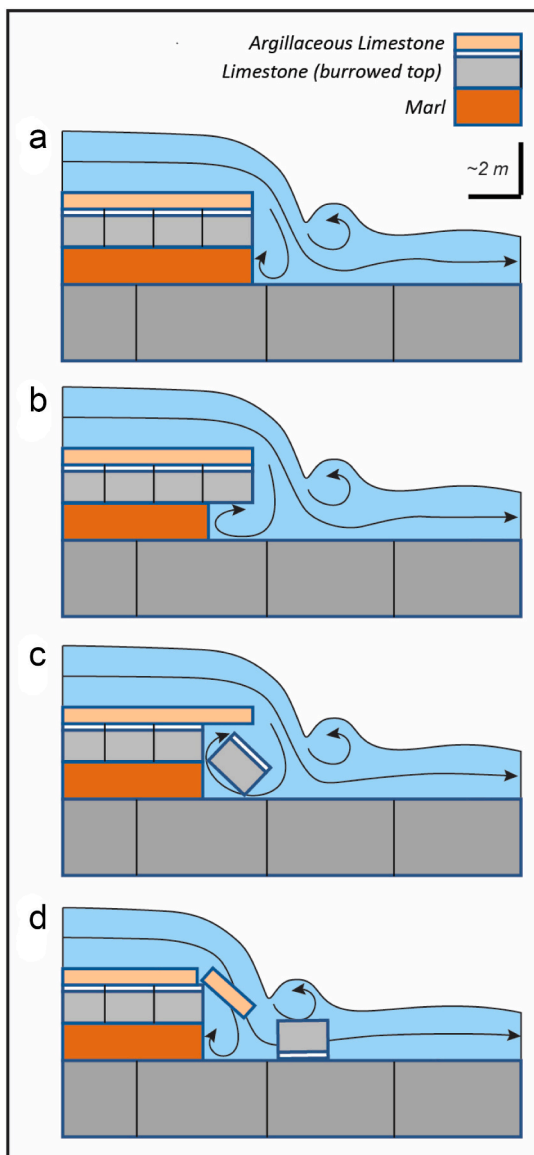
Headward erosion or the recession process follows a recurring sequence. Based on observations and data gathered at Canyon Lake gorge, a conceptual erosion model specific to this study site is presented (Fig. 9). The first step of the erosional process initiates with water traveling downstream and flowing over the cliff at the downstream edge

Fig. 9. Model for sequential undercutting and block toppling in mechanically layered limestone and marl. Erosion of weak marl at base of waterfall undercuts beneath limestone which progressively destabilizes fractured limestone and leads to blocks toppling out of cliff, and collapse progressing to the top of the cliff. This process repeats as eroded blocks are transported by current downstream and marl continues to undercut at base of cliff.

of the spillway (Fig. 9a). This water entrains sediment that impacts and recirculates at the bottom of the cliff, forming an erosional vortex current that scours or abrades the softer clay-rich marl layer causing erosion. Next, continued erosion of the clay-rich marl produces undercutting of the overlying erosionally resistant limestone (Fig. 9b). Continued erosional undercutting leads to the marl becoming eroded enough to expose or reactivate fractures in the overlying limestone layer. In this case, the flow is perpendicular to the dominant regional fracture set (Set 1), and these fractures serve as the primary release planes for blocks to topple or collapse from the waterfall headwall (Fig. 9c). The fourth step in the erosional process is the failure of the unstable marl above the limestone due to overhang and mechanical

weakness – this may occur during collapse of the underlying limestone block or be delayed during progressive collapse (Fig. 9d). After collapse of the cliff, renewed erosion of the clay-rich marl catalyzes undercutting and the process repeats.

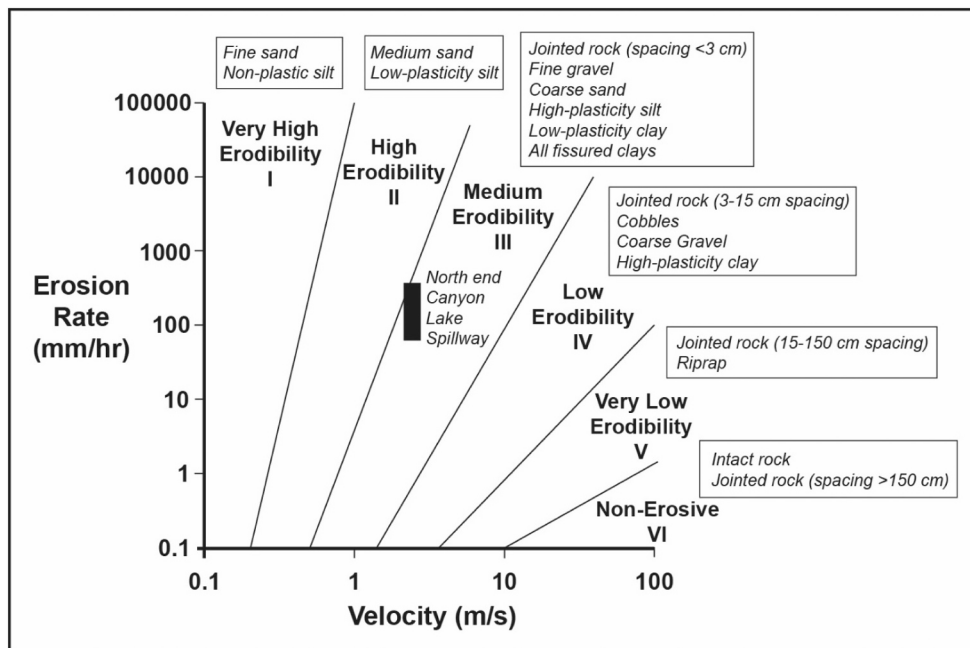
Observations presented here indicate fundamental influence of pre-existing fractures on recession along the waterfall lip at the Canyon Lake spillway. This is consistent with the results from past erosion studies and analysis methods (e.g., Annandale, 2005; Pan et al., 2014), and of Bishop and Goldrick (1992) that indicated that failure along joint planes at waterfall lips enhances retreat as part of a more complicated process than the simple model for undercutting beneath a competent caprock layer that has been interpreted for Niagara Falls. Erodibility has been defined as the relationship between the velocity of the water flowing over the soil or rock and the corresponding erosion rate experienced by the soil or rock (Briaud, 2008; Briaud et al., 2008). Briaud et al. (2008) notes that rock erodes through two main processes of rock substance erosion and rock mass erosion, with the distinction that rock mass erosion involves removal of rock blocks from a jointed rock mass which is particularly important for high turbulence events. The erodibility of the north end of Canyon Lake spillway can be evaluated through comparison with erodibility analyses of Briaud, (2008) and Briaud et al. (2008). Erosional recession rate at the north end of the spillway was 56 to 417 mm/h (based on 5 to 28 m recession occurring over 2.8 to 3.7 days) and 2.35 m/s velocity ($1897 \text{ m}^3/\text{s}$ peak discharge divided by 2.1 m water depth and 384 m width of emergency spillway) (Fig. 10). On a graph of erosion rate versus velocity (after Briaud, 2008), the erosion rate observed at Canyon Lake spillway plots in the area of medium (to high) erodibility (Fig. 10), which would typically be associated with unlithified clay, sand, or gravel, or intensely fractured rock with joint spacing $<3 \text{ cm}$. In contrast, the limestones in the spillway cliff have mean joint spacings of 77 cm, 252 cm, and 256 cm, which according to Briaud et al. (2008) should be expected to have very low erodibility and would be expected to experience erosion at the observed recession rates only at flow velocities two orders of magnitude higher than the actual flow velocity. Although the jointed limestone in isolation would be expected to have very low erodibility according to Briaud et al. (2008), the greater erodibility of the underlying marl – with behavior similar to low-pasticity clay – led to undercutting of the limestone and “medium erodibility” of the composite section.

Fig. 10. Erosion rate versus water flow velocity at the north end Canyon Lake spillway is compared with erodibility of common geological materials including unlithified sediments and fractured bedrock. While competent limestone layers with fractures spaced more widely than 15 cm would typically lie between regions V – Very Low Erodibility and VI – Non-Erosive, the erosion of the limestone layers in the spillway at Canyon Lake plots in the region II – High erodibility to III – Medium Erodibility. This behavior is governed by the erodibility of the underlying marl, which behaves similarly to low-plasticity clay, and localizes undercutting to catalyze collapse of fracture bounded limestone blocks.
